EXHIBIT Q

Documenta Ophthalmologica 61, 303–312 (1986). © Dr W. Junk Publishers, Dordrecht. Printed in The Netherlands.

Mechanical and biochemical effects of man-made fibres and metals in the human eye, a SEM-study

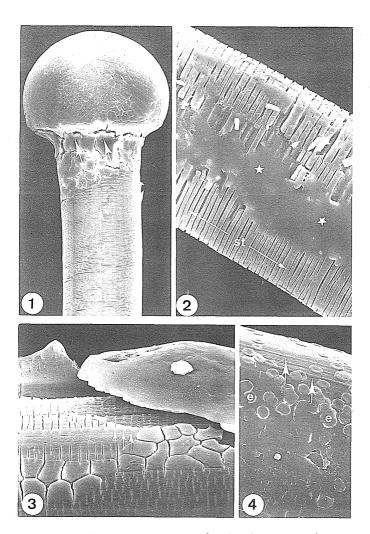
Both prolene loops showed severe degradation of the surface layer. Figure 1 shows part of one of the loops with a very regular pattern of striations (st) perpendicular to the longitudinal axis of the loop. The rounded end of the loop and the beginning of the straight part of the loop are covered with a rather thick layer of deposits of an unknown substance which contains many erythrocytes (e). The irregular cracks in this deposit (see arrows) are due to drying, a common phenomenon in SEM-specimens of inhomogenous structure. Figure 2 shows at higher magnification the very regular pattern of striations (st); some parts of the surface are covered with a thin deposit (*). comparable to the layer seen in Figure 1. The degradation of the surface layer can be observed in more detail in Figure 3. Part of the surface layer is detached, exposing the sub-surface layer, which shows a similar cracking pattern (see arrows). Although the cracking can have been enhanced by the drying process, the loops and lens were dried in air, the fact that the sub-surface layer shows a similar cracking pattern of degradation is a clear indication of biodegradation. If the phenomenon we observe were the result of the drying of a deposit, then the cracks in it would have a much more irregular character, like the cracks seen in Figure 1 on the rounded top. Moreover the total diameter of the degraded loop has certainly not increased, which would be the case if the result we observe was caused by the deposition of material.

That part of the loop (close to the lens) which was not in contact with tissue did not show the degradation phenomenon, but was merely covered with a very thin deposit, consisting mainly of erythrocytes (e), Figure 4. The layer of deposit is very thin, as can be concluded from the longitudinal lines, caused by the manufacturing process, which are still visible despite the deposit (see arrows).

Figures 1-4. Prolene: Figure 1 (155 \times), part of prolene loop; e = erythrocyte covering; st = striations of biodegradation; arrows denote deposited organic matter. Figure 2 (370 \times), degraded surface; * = deposited organic matter; st = regular pattern of striations. Figure 3 (770 \times), detail of degraded surface layer. Figure 4 (370 \times), non-degraded prolene surface; e = erythrocytes; arrows denote manufacturing grooves.

We think that the surface changes observed in the implanted prolene are the result of biodegradation by the enzymatic action of the tissue fluids. Although the cracking pattern on the surface may be enhanced by the drying, the changes are the primary result of chemical changes on the surface.

This conclusion is supported by the images of the *sub*-surface layer, where lines appear perpendicular to the longitudinal axis of the loop, which are not present in the control sample. In some places a deposit is visible on top of the surface layer of the implanted prolene; this layer is very thin and not in any way comparable with the attacked layer. If the phenomenon of what we call biodegradation is the result of a deposit of, for example, a proteinic material, a quantitative increase in the average diameter would be the result. The total diameter at such sites did not increase but, on the contrary, tended to decrease slightly. Moreover the cracks (striations) are so regularly spaced over a large part of the implanted loops that they must be the result of prolene degradation and not of the mere drying of a deposit.

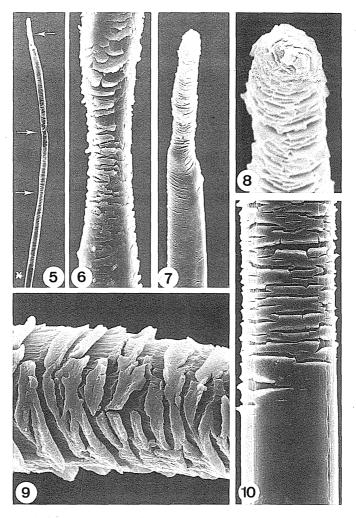
not show this. The attack was so serious that the ends became so thin that they lost their strength and broke off. Figure 5 shows the broken end of one of the sutures at low magnification. In several places (see arrows) the suture had a smaller diameter than average. This considerable decrease in diameter is something we did not observe with prolene. The main part of the suture in Figure 5 shows a degraded surface, except for the part indicated by (*).

A thinner part of the suture is shown in more detail in Figure 6, the

Figures 5-10. Perlon: Figure 5 (38 \times), low magn. broken Strampelli suture; arrows denote decreased diameter; * = non-degraded part. Figure 6 (390 \times), detail of suture with decreased diameter. Figure 7 (175 \times), broken end of suture. Figure 8 (595 \times), detail of Figure 7. Figure 9 (1330 \times), detail of degraded surface. Figure 10 (450 \times), transition non-degraded (lower part) – degraded surface.

surface of the suture is degraded. The broken end of the suture is depicted in Figure 7, it has a considerably decreased diameter and the surface is degraded. The broken end is shown in Figure 8 at high magnification, note the rough outer surface.

Although not exactly the same, the general pattern of degradation of the surface layers of perlon (Figure 9) and prolene (Figure 2) is comparable. A similar pattern is found on the sub-surface layer of perlon to that seen in

prolene. That part of the suture which had not been in contact with tissue did not show these effects of biodegradation. Figure 10 shows such a transition area in more detail, the lower part of the picture represents the non-degraded surface of the perlon structure.

The effects seen in the perlon material are also the result of biodegradation; in certain places the material got so thin that it lost its strength and broke. Supramid material showed minor degradation effects, longitudinal cracks which may be related to the manufacturing grooves to some extent. In one case (see Addendum) we found, in a very small portion of the total length of all the loops, a similar degradation effect to that seen in prolene and perlon. Thus supramid can undergo biodegradation as well.

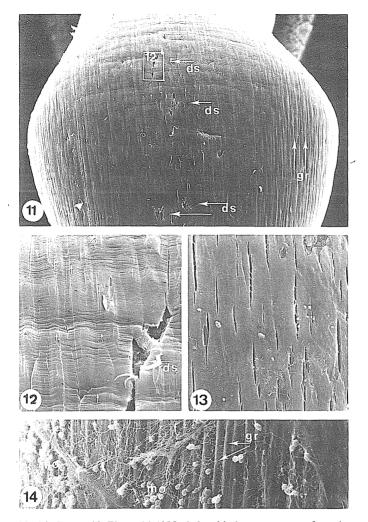
Figures 11–14. Supramid: Figure 11 (455 \times), bend in loop; gr = manufacturing grooves; pl = lines perpendicular to grooves; ds = surface damage. Figure 12 (1530 \times), detail of Figure 11. Figure 13 (950 \times), longitudinal cracks in surface. Figure 14 (1530 \times), gr = manufacturing groove; f = fibres; mo = microorganisms.

The supramid material showed, in particular at bends in the loop, a fine network of lines (see arrows) perpendicular to the longitudinal manufacturing grooves (gr) of the loop (Figure 11). On the median part of the loop, clear evidence of surface layer damage can be seen (ds). Figure 12 shows a detail of such a site and its relationship to the fine network already mentioned. In Figure 13 longitudinal cracks are visible on the surface of the supramid loop, possibly the start of biodegradation. These cracks are found in the vicinity of bends in the loop at some distance from them, implying that this type of degradation is related to weak spots in the loop, particularly bends due to the manufacturing process. The general pattern of the surface is not one of severe degradation, as compared to the degradation seen in prolene and perlon, at least not in the loops we investigated.

The relatively rough outer surface of supramid, as compared with prolene and perlon, certainly facilitates the adherence of fibres, cells and microorganisms, as can be seen in Figure 14. The picture shows the almost complete diameter of the loop with fibres (f), possibly fibrin, and microorganisms (mo) covering the manufacturing grooves (gr) of the supramid.

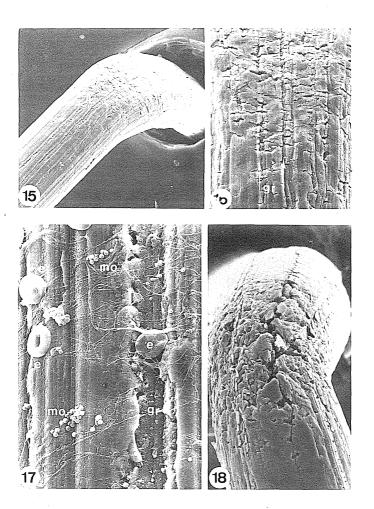
Titanium showed a rough outer surface, particularly at bends in the loop; in the straight part of the loop the longitudinal lines can be seen caused by the manufacturing process (Figure 15). The longitudinal grooves (gr) and the cracks more or less penpendicular to them can be seen in more detail in Figure 16 (area (A) of Figure 15). The roughness of the titanium surface facilitates the adherence of microorganisms (mo), fibre-like material and cells, especially erythrocytes (e), visible against the background of manufacturing grooves (gr) in Figure 17.

This roughness is already present in non-implanted material, as can be observed in Figure 18. The cracks in the surface layer particularly at the bends in the loop, visible in non-implanted as well as implanted material (see Figure 16), are some kind of mechanical degradation probably caused by, or at least initiated by, the manufacturing process.

This roughness also contributes considerably to irritation and inflammation of the tissue which is in contact with this material. In comparison with titanium, stainless steel-vanadium and, in particular, platinum wire have a much smoother surface.

Figures 15–18. Titanium: Figure 15 (190 \times), bend in implanted loop. Figure 16 (455 \times), detail of surface of bend; gr = grooves. Figure 17 (1230 \times), detail of loop surface; mo = microorganisms; e = erythrocytes; gr = manufacturing groove. Figure 18 (345 \times), detail of bend in non-implanted loop.

Both supramid and titanium have initially a rather rough outer surface, which facilitates adherence and, in the case of titanium, contributes to irritation and inflammation of the tissue with which it is in contact.

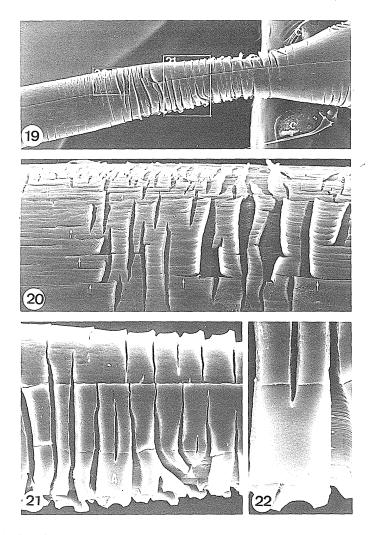
one loop situated close to the IOL (see Figure 19), which showed severe biodegradation. The diameter of the loop had decreased at this site. The IOL showed some cell deposits around the loop 'entrance' (c). The degradation pattern is quite similar to that found in prolene and perlon (see Figures 20 and 21, both details of Figure 19). From Figure 20 it seems logical to assume that the degradation is connected with the surface morphology of the supramid surface. The longitudinal cracks (see arrows) are comparable with those found in Figure 13, which can be related to the manufacturing grooves. The

Figures 19–22; Supramid: Figure 19 (75 \times), part of loop close to IOL; c = cell deposit. Figure 20 (455 \times), detail of Figure 19; arrows denote longitudinal cracks. Figure 21 (275 \times). detail of Figure 19; severe degradation of surface. Figure 22 (610 \times), detail of Figure 21, inside of crack.

striations perpendicular to these cracks are comparable with the striations found in prolene (Figure 2) and perlon (Figure 9), although less regular.

Figure 22 shows more detail of the inner part of the surface layer (enlargement of part of Figure 21). From this picture we can conclude that the loosened surface layer does *not* have an amorphous structure, which would be the case if it was merely a deposit of, for instance, proteinic material. Arrows denote the cross-section of the loosened surface layer.
